WAKE COUNTY HISTORIC PROPERTY DESIGNATION APPLICATION FORM

Historic Name: John T. and Mary Turner House

Street Address: 1002 Oberlin Road

**WAKE COUNTY HPC
LANDMARK DESIGNATION APPLICATION**

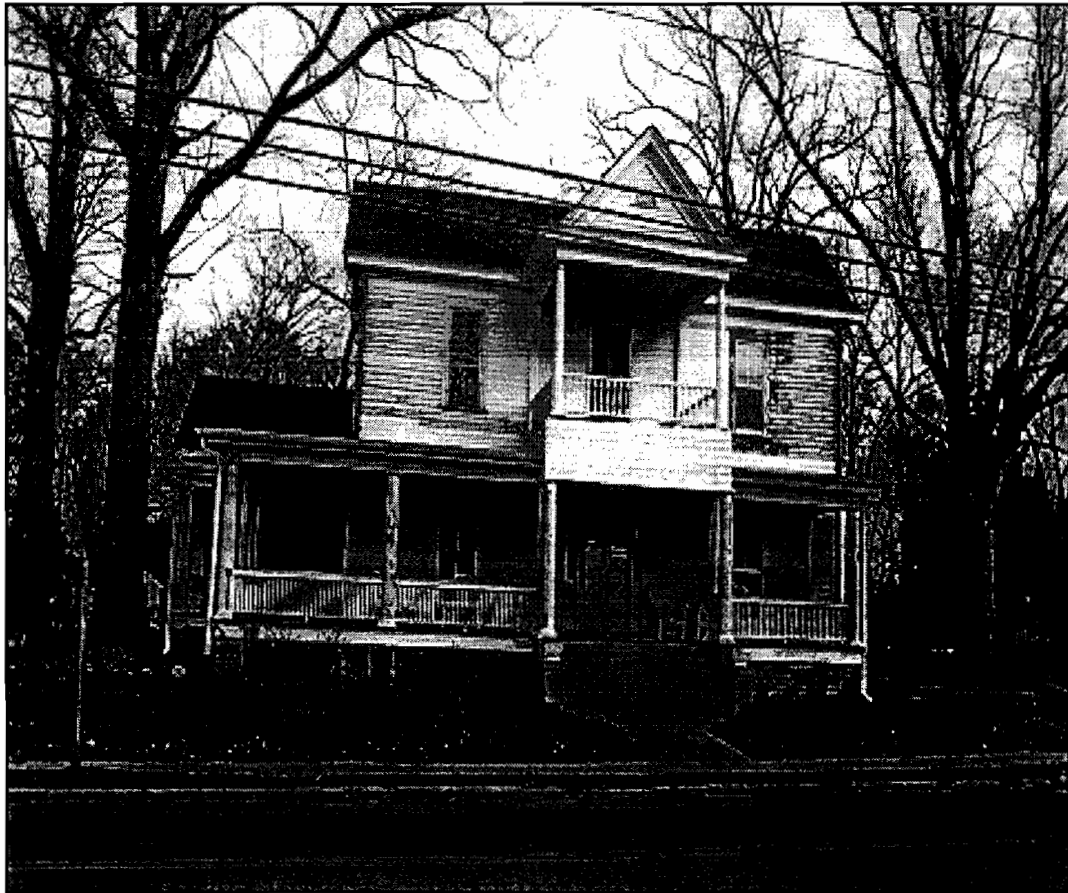
Front (west) Elevation

The Turner House is a frame, weatherboarded Neoclassical Revival I-house with two one-story ells.

The main, two-story or I-house section, is one-room deep; has an asymmetric, one-story, wraparound porch which extends to the side ell; a second-story, pedimented, one-bay balcony; and a three-sided bay window on the south facade, finished with narrow, beaded, tongue-and-groove sheathing and small cornice brackets. The wraparound porch has a flat roof, Doric columns, and simple square balusters. The balcony has Doric columns, spindle balusters, and wooden shingles beneath the balustrade.
